## Present status of the BigRIPS cryogenic plant

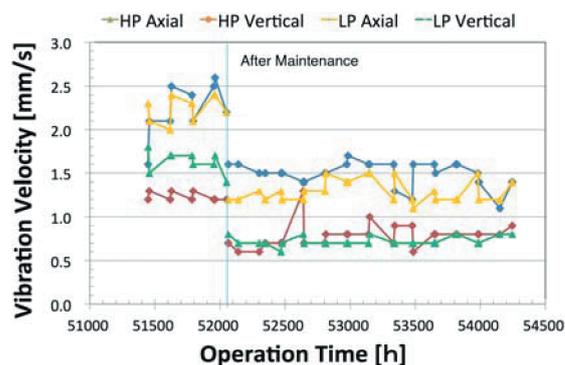
In September 2014 we have started the continuous operation of the BigRIPS cryogenic plant and stopped the main compressor in July 2015. After the summer maintenance, we started the cryogenic plant in mid-September and stopped the compressor in December 2015. During these continuous operations, we faced some troubles on the compressor unit. One is an unusual noise that was produced by the main motor unit in May 2015. We greased the motor unit and maintained the continuous operation. In other incidents, the compressor unit suddenly stopped that happened twice in May 2015. The failure of the temperature transducer for the discharge helium gas caused false interlock stops. We replaced the temperature transducer and continued the operation. After these incidents, we have started measuring the vibrations of the main compressor unit for sound operations.

Figure 1 shows the vibration velocities in the axial and vertical directions as a function of the total operation time. We measured vibrations both at the high-pressure (HP) and low-pressure (LP) sides of the main compressor unit using the handy vibration tester OH-580A<sup>4)</sup>. It is clearly seen that the vibration velocity changed drastically before and after the maintenance.

Fig. 1. Vibration velocity of the compressor unit.

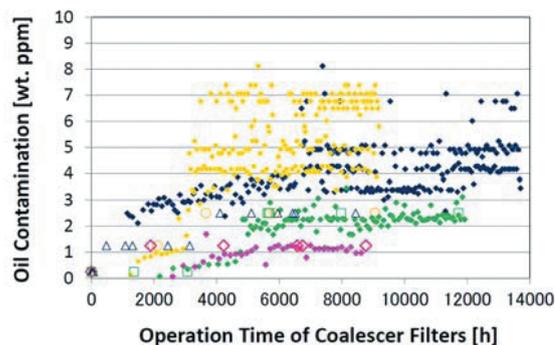
Figure 2 shows an estimate of the oil contamination level at the entrance of the third coalescer vessel as a function of the coalescer filter operation time. As stated by Kusaka et al.<sup>2)</sup>, the amount of oil drain from the vessel is directly related to the oil contamination level. The navy blue, green, and yellow diamonds represent the estimates for the 2008-2009, 2010-2011, and 2012-2013 operations, respectively. The coalescer filters used in those periods were discontinued<sup>3)</sup>. The estimate for the 2014-2015 operation with successive new coalescer filters is shown as pink diamonds. The oil contamination measurement values using the oil check kit are also shown. The open triangles, squares, circles, and diamonds represent the results for the 2008-2009, 2010-2011, 2012-2013, and 2014-2015 operations, respectively. The performance efficiency of the new filter elements seems to be similar to or better than that of the discontinued ones.

Fig. 2. Oil contamination at the entrance of the third coalescer vessel.
