## Incidents involving the DMT3 magnet in the beam transport line from SRC to BigRIPS

K. Kusaka,\*<sup>1</sup> K. Yoshida,\*<sup>1</sup> M. Ohtake,\*<sup>1</sup> and Y. Yanagisawa\*<sup>1</sup>

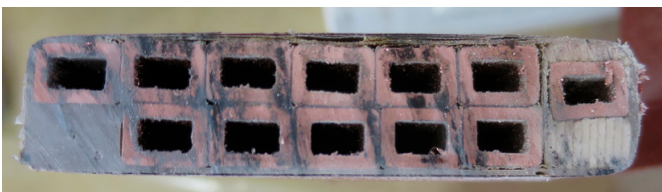
We investigated the cooling-water channel in the damaged correction coil by cutting the coil conductor. We cut the damaged coil into 11 pieces. Figure 1 shows, as an example, a cross section of the correction coil cut at a saddle-shaped coil end. Although we found no notable evidence of blockage by impurities, it is likely that a shortage of heat removal due to poor cooling-water flow in the correction coil damaged the epoxy isolation.

Fig. 1. Cross section of the damaged lower correction coil at the saddle-shaped coil end.

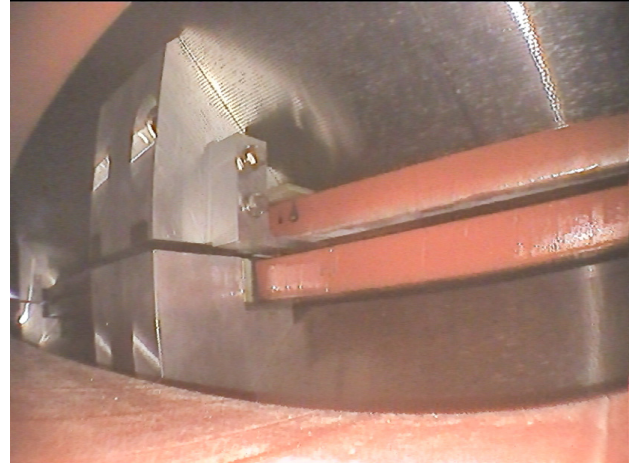
Fig. 2. Damaged upper correction coil of the DMT3 magnet.

131.6 V, which was about 10 V lower than the voltage of the DMT2 magnet (141.2 V). Furthermore, the temperatures of the cooling-water outlet of the upper and lower correction coils of the DMT3 magnet were 20.5°C and 40.1°C, respectively. We concluded that the upper correction coil in the DMT3 magnet was short-circuited.

We investigated the upper correction coil by inserting a fiberscope CCD camera into the space between the main coils of the DMT3 magnet after the beam time. Damage was found at the position of the second coil support from the beam exit side. Figure 2 shows the damage on the outer circumference of the upper correction coil. The origin of the incident is under investigation.

In order to complete the beam service successfully, we isolated the upper correction coil from the excitation circuit, as we had done in 2017. The DMT3 magnet was re-excited while monitoring the voltage of each coil pancake.

Furthermore, we introduced an additional auxiliary DC power supply in the DMT3 excitation circuit in a parallel connection. Water-cooled protection diodes were also used for safety. We excited the DMT3 magnet using two power supplies with currents of 110 A and 536 A so that the uranium beam was safely transported to the BigRIPS target from SRC. After 2 days of beam-time suspension, scheduled experiments were performed till December 6. At the end of the beam time, we tested the transportation of the uranium beam using the DMT3 magnet without correction coils. We excited only the main coils of DMT3 magnet using two power supplies with currents of 110 A and 563 A. We confirmed that the uranium beam focused on the BigRIPS target well and the main coils were well cooled with a sufficient water flow.
