Equipment and procedures for safe handling of activated material

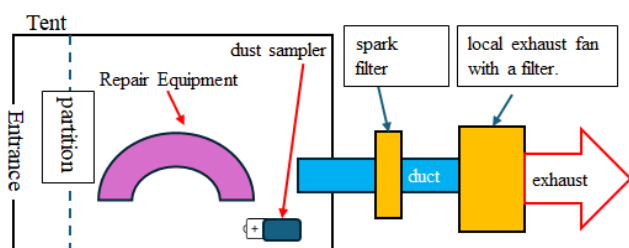
Figure 1 shows the workhouse of internal-radiation safe called Tent used for the repair set in the IRC room. The size of Tent is 2.5 m wide, 5 m long, and 2 m high. Tent is ready-to-assemble made of flame-retardant sheets to prevent fire caused by welding sparks. The sheets can be cut into small pieces to dispose easily even if they are contaminated with radioisotopes. The entrance has an opening for easy access to the large equipment. A partition is placed at the entrance to provide space for changing contaminated protective clothing. Additionally, the floor sheet and Tent can be separated so that the large equipment can be imported from above. Air containing radioactive airborne dusts from the processing work of radioactive material in Tent can be exhausted outside by a local exhaust fan with a high-performance filter. The air inside the 25 m³ volume Tent was replaced once/min by an exhaust fan. Two types of filters, pre and HEPA filters, are stacked to remove radioactive dust. HEPA filters had a collection efficiency of 99.97% for particles 0.3 μm in diameter or larger. The exhaust ducts were made of aluminum, and a spark filter box with stainless steel wool was placed between Tent and the local exhaust fan to prevent sparks by welding from entering the local exhaust fan and igniting it. Moreover, two layers of spark sheets and flameproof sheets were used on the floor to withstand sparks generated by welding.

Fig. 1. Schematic view of the Tent used for the repair.

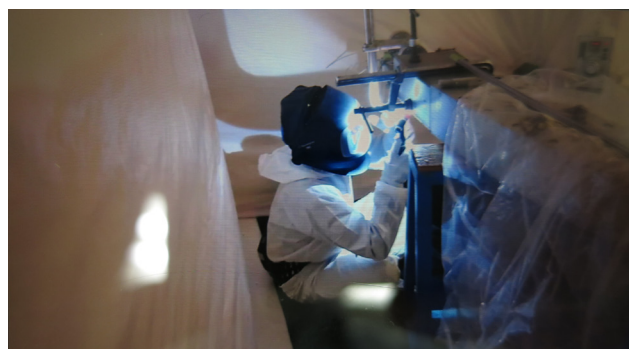
Workers welded with digital dosimeters with alarms to keep external exposure below limited value of 200 $\mu\text{Sv/day}$. Figure 2 shows a TIG welding operation with the mask and the protective suit.

Fig. 2. TIG welding operations.
