## Restoration of SRC vacuum leakage

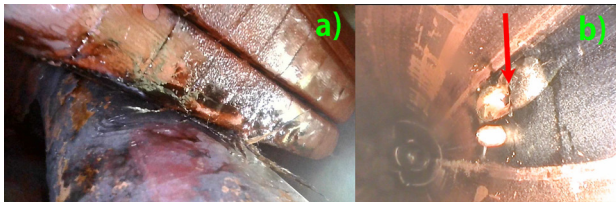
Therefore, the survey was first conducted from the downstream side of the MDC3. Although the exact location of the leak could not be found owing to the high residual radiation and the narrow and secluded location of MDC3, discoloration of the copper beam duct, carbonization of the polyimide tape, and blackening of the coil insulation epoxy resin were observed as shown in Fig. 1(a). This indicated that the beam duct was considerably heated.

Fig. 1. Outside view of the downstream side of MDC3 (a) and the inside of the beam duct (b). Melting point is indicated by the red arrow.

Next, we entered the acceleration resonator no. 4 and examined the inside of the beam duct from the upstream side of MDC3 using a fiberscope. As shown in Fig. 1(b), we found a spot melted by the beam on the right side of duct. To close this hole, the MDC3 had to be removed from inside the SRC body, which was an extensive repair job.

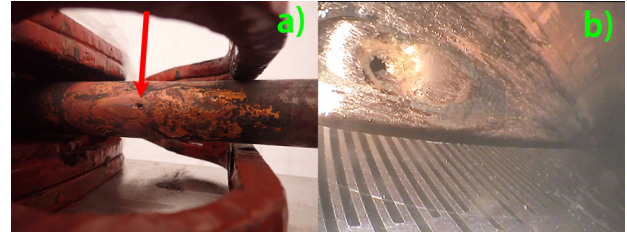
Fig. 2. Photographs of the hole made by the beam.

lowing the removal of debris in the beam duct. The size of the hole was approximately 2 mm, and the extent of inward bulging of the molten area was considered to be approximately 7 mm in the direction of beam axis.

The cause of the beam hitting the duct is not clear; however, it is most likely that the RF voltage of the upstream accelerator, fRC, became unstable. The baffle slit on the SRC extraction was excessively thin, the  $^{70}\text{Zn}$  beam did not stop, and the interlock did not work. Therefore, we are currently working on improving the RF stability of fRC and replacing the baffle slit with 10 mm thick.

As the MDC3 cannot be disassembled because the coil and copper duct were integrally cured, we decided to arc spot weld a 1 mm-thick copper patch all the way around. The copper duct with the patch welded and repaired is shown in Fig. 3(a). The damaged insulators of the coils were also repaired as depicted in Fig. 3(b) and their integrity was confirmed by measuring the insulation resistance. Four thermocouples were mounted on the copper duct to measure temperatures and detect large beam losses. The restoration work was completed at the end of May 2023 by returning the MDC3 to SRC and performing a vacuum leak check.

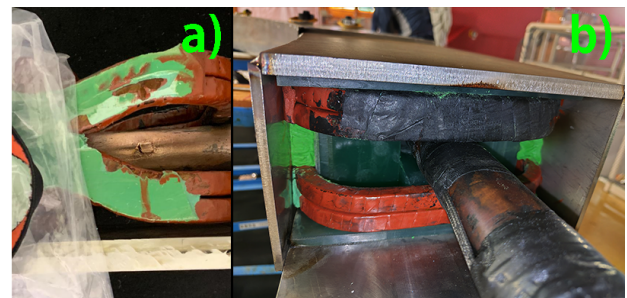
Fig. 3. Photo of MDC3 after repair work.
