# **RIKEN RING CYCLOTRON (RRC)**

RIKEN Nishina Center, Wako, Saitama, Japan

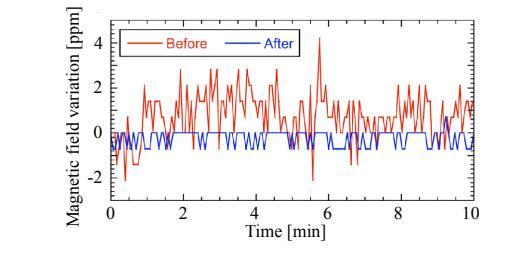
Two main coils of sector magnets exhibited signs of layer shorts, and an epoxy resin and glass fiber tape were carbonized throughout each layer short. Therefore, these main coils were both replaced [4-6]. In May 2011, a layer short that was causing the RRC magnetic field to fluctuate by as much as  $\pm 20$  ppm was found in the upper main coil of the RRC-E sector magnet. We found that it would be nearly impossible to repair the coil and therefore decided to fabricate a new RRC main coil, which replaced the old one in the summer of 2012. Because the RRC main coil had never before been replaced, the task was scheduled to be performed over a period of three weeks. In June 2012, the lower main coil of the RRC-W sector magnet also whibited signs of a layer short. This layer short in the RRC-W sector magnet was identical to the short identified and renaired in 1000 W using the same method that had been used in 1999, but  $\overline{\mathbf{q}}$  the fluctuations of the coil voltage and magnetic fields were not fully corrected. Thus, we decided to replace the  $\overline{\mathbf{v}}$ damaged lower main coil and the deteriorated upper main Se coil of the RRC-W sector magnet with new main coils; these were replaced in the summer of 2013. The task was scheduled to be performed over a period of eight weeks because we had never before replaced the lower main coil of the RRC during the entire 26 years of operation. Though the magnetic field of the RRC-W sector magnet before the replacement had been fluctuating over a wide

range of  $\pm$  5 ppm, the field of the new magnet is stable and exhibits no fluctuation, as shown in Figure 2.

Figure 2: Fluctuation of magnetic field before and after replacement of W-sector main coils.

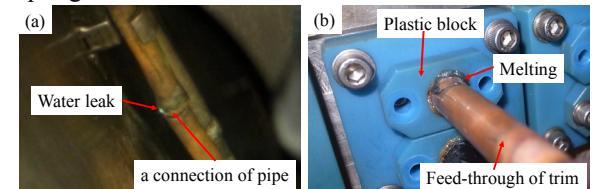
In April 2012, a vacuum leak occurred in the electric power feeder of RF resonator No. 2. This vacuum leak was attributed to a crack in the insulator and to the partial melting of the aluminium gasket. Therefore, the insulator and gasket were replaced with new ones. In the spring of 2013, a vacuum leak occurred in the inner copper cooling-water pipe for the lower dee electrode in the resonator No. 2 cavity. So, the cavity was opened in July, and the inside of the inner conductor was investigated carefully. The water leak occurred at a connection in the inner copper cooling-water pipe, as shown in Figure 3 (a), but it was impossible to repair the leak point due to the narrowness of the space surrounding the pipe. Therefore, because a new bypass line was made for the lower dee electrode, this pipe line was cut at some spot and connected with a new pipe using a sleeve and a silver braze. In October 2013, a vacuum leak occurred in a lower feed-through trim coil in the E-sector sub-chamber [2-3]. So, the E-S valley cavity, which is located next to these lower feed-through trim coils, was opened to perform these repairs in the summer of 2014. Three Orings and plastic blocks for the feed-through had been melted, as shown in Figure 3 (b). The feed-through was cut at each melted location because there was no coupling to enable desorption of the O-rings and plastic blocks. The melted O-rings and plastic blocks were replaced with new ones, and the feed-through was again connected with coupling.

Figure 3: RRC vacuum leaks: (a) connection of the inner copper cooling-water pipe, (b) O-rings and plastic blocks for feed-through.

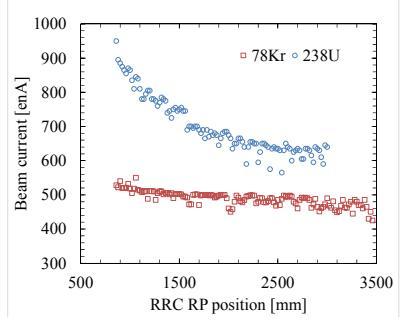
Though a vacuum of about  $2 \times 10^{-5}$  Pa is currently present in the two resonator cavities, beam loss is increasing more than before. Figure 4 shows the circulating beam currents of <sup>78</sup>Kr and <sup>238</sup>U that were measured by a radial probe (RP) in a  $1.6 \times 10^{-5}$  Pa vacuum in the winter of 2015 [2]. The RP position is defined as the distance from the center of the circulating orbit. Though the <sup>78</sup>Kr beam current only decreases by about 9 %, that of the <sup>238</sup>U decreases substantially, by more than 30 %. This <sup>238</sup>U beam current loss is six times greater than 5 % that measured in 2012, so it is necessary to repair the remaining leaks.

Figure 4: Circulating beam currents of <sup>78</sup>Kr and <sup>238</sup>U.

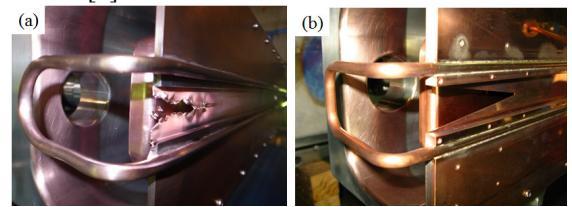
During the U-beam service time in November 2012, a septum electrode of an electrostatic deflection channel (EDC), which deflects the circulating beam to the extraction orbit, was seriously damaged on the injection side by significant beam loss, as shown in Figure 5 [3]. After this issue arose, a beam interlock system was installed to monitor the temperature of the EDC septum electrode of the RRC and to reduce the heat load. Furthermore, a new EDC septum electrode structure was designed, in which the septum electrode forms a V-shape pointing towards the injection side.

Figure 5: EDC: (a) septum electrode damaged by beam loss, (b) new V-shaped septum electrode.
