## Updating control units around the AVF cyclotron

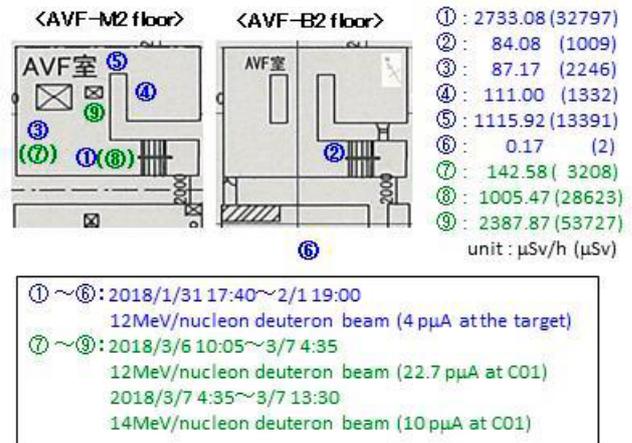
Fig. 1. Neutron dose measurement. The AVF-B2 floor is one floor below the AVF-M2 floor. The data written on the right side shows the average dose (integrated dose).

- (1) To move one of the racks from No. 1 to No. 3 with the N-DIM inside.
- (2) To move some N-DIMs mounted on the rack next to the rack to be relocated to the gap between the existing racks near No. 3.
- (3) To set up some new N-DIMs on the existing racks near No. 3. Remove the signal and control cable from the DIM at No. 3 and AVF floor, and reconnect them to the newly set up N-DIMs.
