## Status of exit-beam dump for BigRIPS

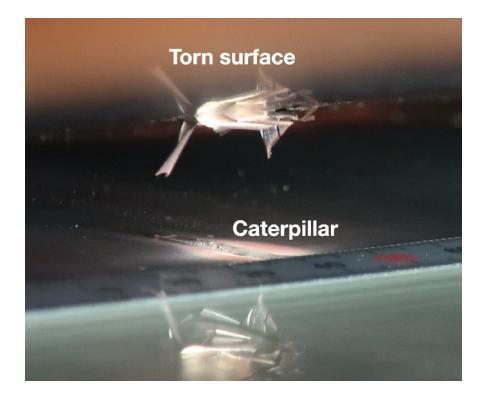
Fig. 1. Surface of the exit-beam dump in May 2023. A scale was placed in front of the caterpillar like structure.

In resolving the specific beam setting responsible for the caterpillar-like structure, we conducted a comparative analysis between the structure's position and the calculated hit positions of primary beams on the dump for each beam setting. The structure's position was measured with a precision of 1-mm. The hit positions of these primary beams were determined by utilizing the beam energies measured by the BigRIPS. The position of the <sup>70</sup>Zn primary beam during the accelerator tuning corresponded precisely with the location of the caterpillar-like structure. Consequently, we posit that the emergence of the caterpillar-like structure is attributed to the impact of the <sup>70</sup>Zn primary beam during the accelerator tuning in December 2022.

A metal thin film retrieved from the torn surface underwent analysis utilizing an electron probe microanalyzer. The results yielded a composition comprising 88% copper, 12% oxygen, and trace amounts of chromium. This composition aligned with that of the exit-beam dump (copper with 1% chromium and 0.2% zircon). Consequently, it was inferred that the torn surface represented a deposition of CuCrZr vapor on the opposing surface of the caterpillar-like structure. This can be torn owing to a large temperature gradient around the deposited position.

The simulation yielded a  $T_{pipe}$  of 217°C, which is lower than  $T_c$ . The dump surface temperature at the beam spot was 378°C, which was lower than the melting point of copper. The simulation also indicated that the dump would melt with a 20% increase in the beam heat flux. Thus, that there may be inaccuracies in the beam size estimation and/or degradation of dump's cooling capability.

We will continue using the exit-beam dump with the molten mark. Several interlocks will be added for safe operation of the dump. In addition, a test will be performed to conclude the cause of the molten mark.
