Operation of the BigRIPS cryogenic plant

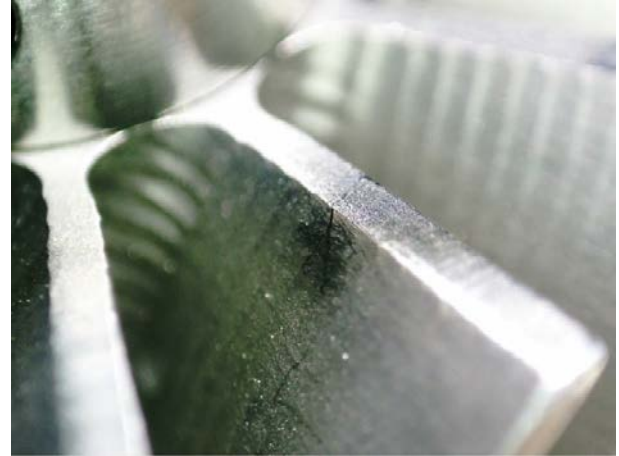
Fig. 1. T2 compressor wheel with scratches.

As reported in Refs. 1) and 2), the first expansion turbine T1 in the refrigerator (cold box) of the BigRIPS cryogenic plant experienced two failures, and the turbine wheels were replaced with new ones and re-assembled with new axial bearings in 2022. The second expansion turbine T2 was also partially repaired for preventive measure in 2023. Because scratches were observed on the T2 compressor wheel in the regular inspections, we shipped the T2 cartridge to its manufacturer Linde in October 2023 (Fig. 1). They disassembled the cartridge and inspected the turbine wheels using a dye penetrant test. Although no crucial damage was detected by the test, the compressor wheel seat was out of tolerance and wear marks were observed on the upper axial bearing. The compressor wheel and upper axial bearing were replaced with new ones, the T2 cartridge was re-assembled, and the cooling water channels were cleaned. The T2 cartridge was returned to RIKEN and re-installed on the cold box in early February 2024. We then tested the cold box unit before the continuous operation of the entire BigRIPS cryogenic plant.

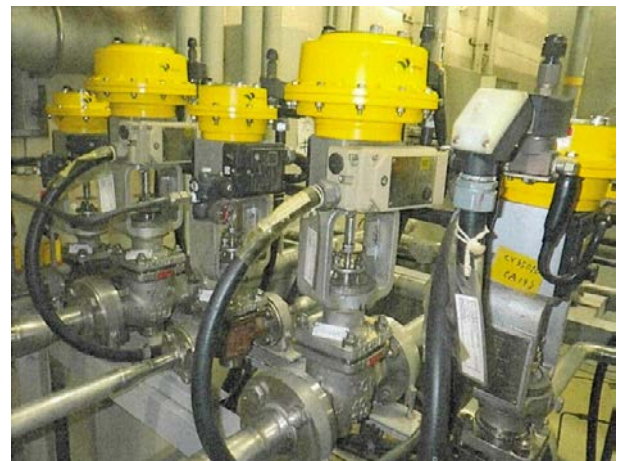
We performed two continuous operations of the BigRIPS cryogenic plant in 2024. The first operation period was from February 29 to July 10 and the second was from September 28 to December 25. Between these dates, we performed periodic maintenance. During maintenance last year, a small gas leak was observed in the valve unit. Therefore, the corresponding seven control valves were disassembled and inspected (Fig. 2). All seven control valves had sliding scratches on the

Fig. 2. Control valve unit in the RIBF compressor room.

valve plugs, which were restored after polishing with sandpaper and verified to be leak-free.
