Construction of PHENIX Silicon Pixel Tracker

H. Torii,^{*1} Y. Akiba,^{*1} H. Asano,^{*1} T. Hachiya,^{*1} M. Kurosawa,^{*1} T. Moon,^{*1} H. Nakagomi,^{*1} C. Pankcake,^{*2} H. Sako,^{*1} S. Sato,^{*1} T. Sumita,^{*1} A. Taketani,^{*1} and the PHENIX VTX group

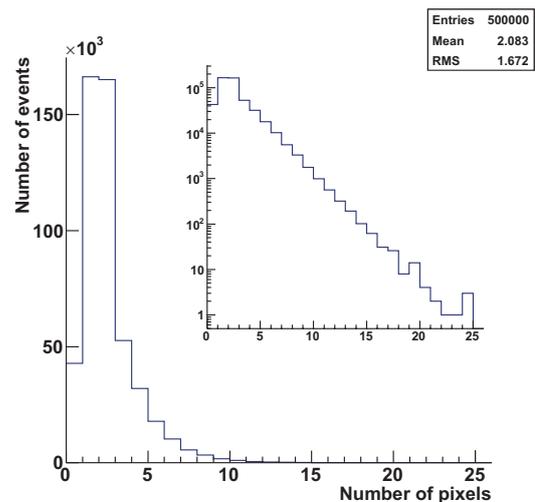
Fig. 1. Number of fired pixels per event in 500k beta-ray events by $Sr - 90$ radio active source.

Figure 1 depicts the number of fired pixels per hit. The average of the number of pixels is 2.1, which is consistent with the above estimate. This fact enables us to measure the accurate rate of the active pixel to all pixel by this beta-ray test. Because some beta-ray enters the silicon sensor with angles due to scattering in materials between the radioactive source and the silicon sensor, some gamma-ray produce wider distribution, that is also observed in the figure.

While entire construction procedure, the readout test by the PHENIX readout system²⁾ using electrical pulse and 0.546MeV beta-ray from Sr^{90} are performed three times; before the encapsulation, before the transportation from Wako to RHIC, and before the installation. The main goal of the test is to ensure the electrical connection between the sensor hybrids and the readout bus and to measure the ratio of the active pixels to all pixels. The threshold during the test is set at about $3,000 e^-$ while the nominal noise of the hybrid sensor is expected to be $200e^-$. When a minimum ionization particle penetrates the silicon sensor with the thickness of $200\mu\text{m}$, 14,000 electrons are estimated to be created and collected by pixel pads. The distribution on the pixel pad surface depends on where the

electron and hole pairs are created. If we assume the average distance from pixel pads to such the electrons is $100\mu\text{m}$ that is in the middle of pixel sensor thickness, the 14,000 electrons distributes on pixel pads like gaussian distribution with $100\mu\text{m}$ sigma from a naive estimate. Because one pixel pad has $50 \times 425\mu\text{m}$, two pixel pads is expected to be more than the threshold on average.
